North America

Central America and Caribbean

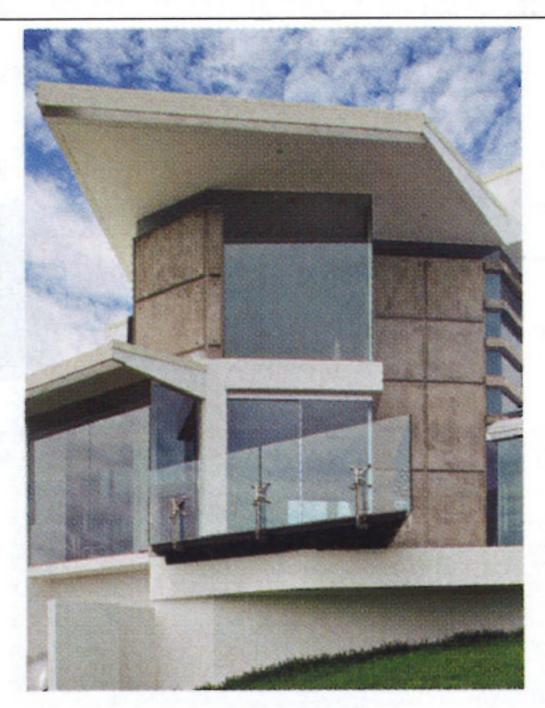
0991 RES 2005

Perched on the side of a mountain spine parallel to the northeast Costa Rican coastline, this house enjoys views of islands, forest and ocean. The driveway's pebbled surface continues inside, with slatted wooden bridges linking sections of accommodation. A curved pool's surface, level with a polished stone patio, appears to merge with the ocean.

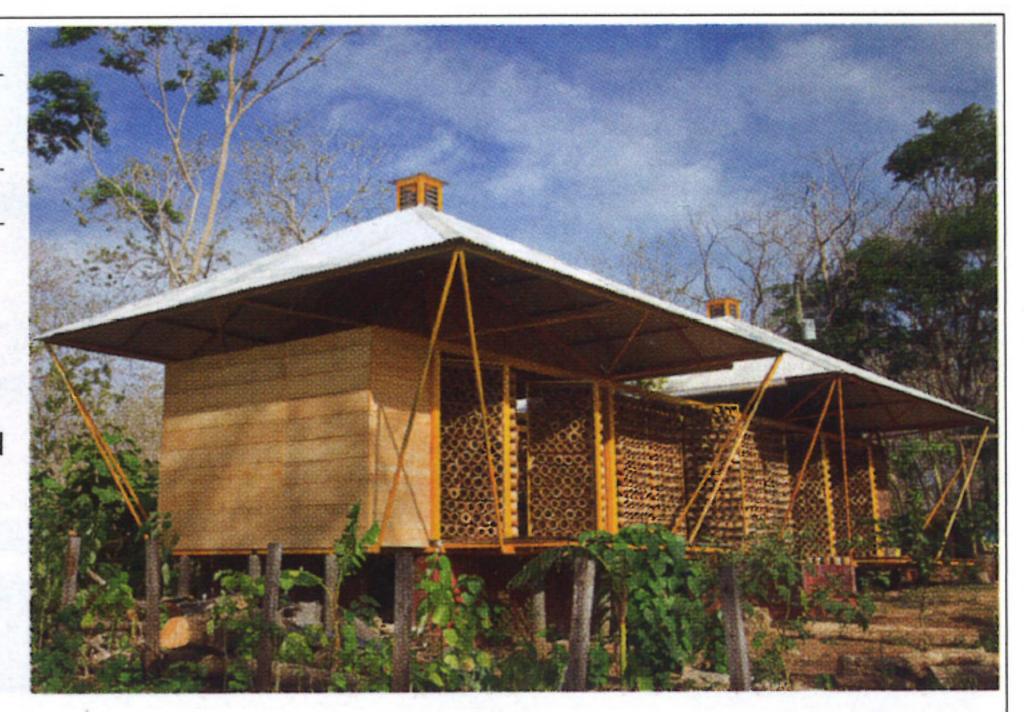
0992 RES 2010

This house, comprising a kitchen and bedroom separated by an outdoor courtyard, is made of simple materials: locally sourced wood and bamboo, concrete, galvanised steel and a corrugated roof with noncorrosive white paint. The perimeter walls are actually screens made from circular cuts of bamboo that naturally ventilate the house.

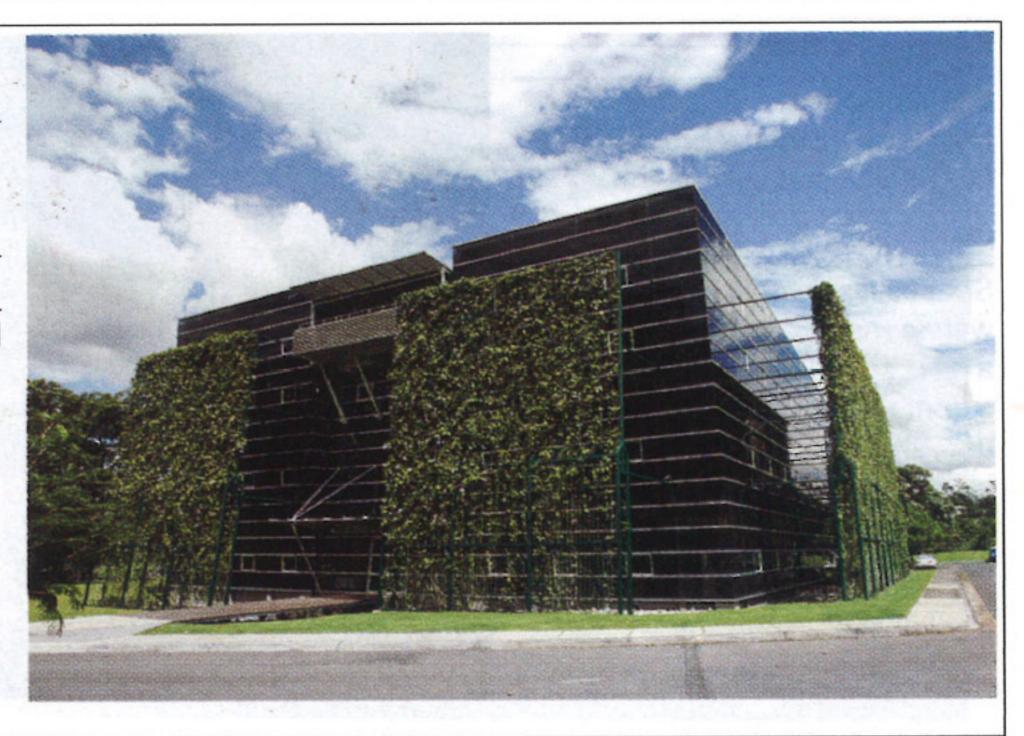
0993 I COM 2004

These offices have planted vertical pergolas attached to each side of the concrete-frame structure, interrupted by the entrance and top-floor balcony. On three levels, the floor plan consists of nine 3 x 3 m (9.8 x 9.8 ft) squares. A glazed curtain wall has opening windows at desk level.
